The Martian Landscape

By The Viking Lander Imaging Team

Scientific and Technical Information Office
NATIONAL AERONAUTICS AND SPACE ADMINISTRATION
Washington, D.C. 1978

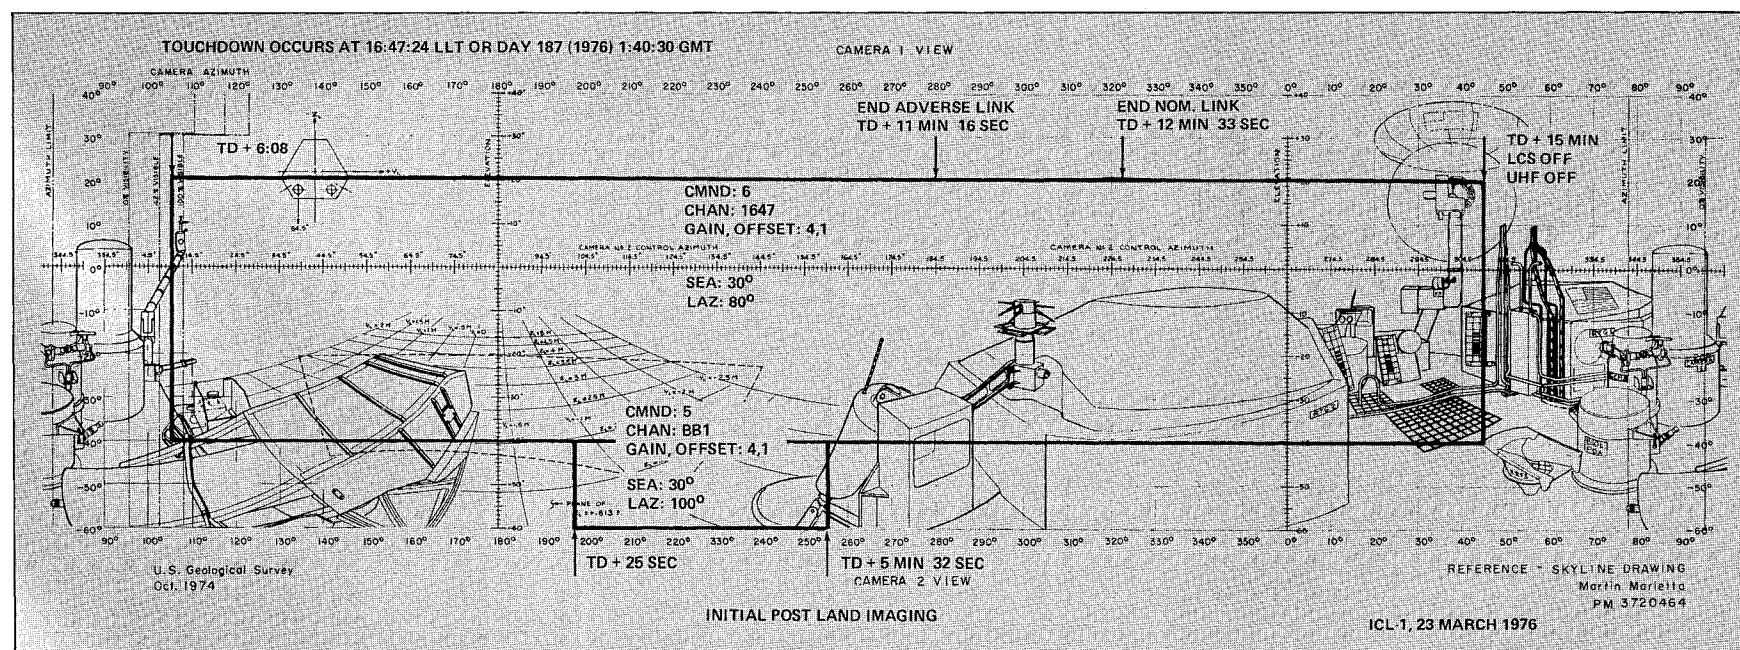
Figure 19. Outlines of the two pictures preprogrammed to be taken within the first 15 min after touchdown on Mars. Compare the camera's "skyline" view of the Lander with the perspective drawings of the spacecraft in figure 9. The times listed in the upper left correspond to the originally scheduled July 4 landing.

The first preprogrammed image was a high-resolution view of the area adjacent to the footpad, the second a low-resolution panorama covering most of the viewing area accessible to the one camera (fig. 19). A number of our colleagues challenged the priorities—"If you were transported to an unknown terrain, would you first look down at

your feet?" Indeed, in a common mental image, the explorer shades his eyes, looking far away to the distant horizon. Our counter argument was relatively pedestrian. A primary photogeologic goal, perhaps because it is so easily quantifiable, is increase in linear resolution. Looking nearly straight down, the slant range was about 2 m, yielding a linear resolution of approximately 2 or 3 mm. Looking toward the horizon, nominally 3 km distant, the linear resolution would be reduced by three orders of magnitude.

The lower edge of the picture is at a slant range of about 1.5 m, the upper edge about 2 m. The larger rocks are about 10 cm across. Refer to figure 19 for location of the picture relative to the spacecraft.

Figure 26 shows the first segment of a 300° low-resolution panorama, the second picture acquired from the surface of Mars. For the location of the picture refer to figure 19.

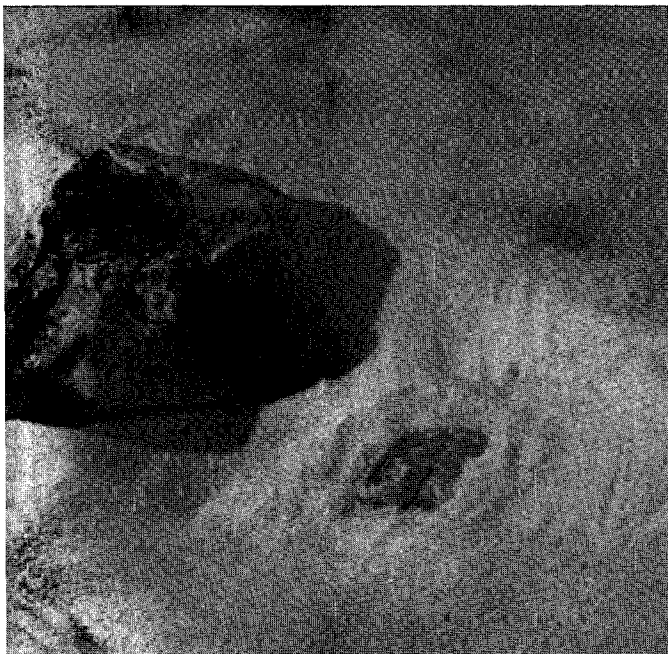
Figure 20. The small object to the right of the larger rock is a fossil trilobite, photographed during one of the mission tests several months before the Mars landing.

from "Mars" were displayed. Of course, these pictures had been taken at a nearby locality and were appropriately coded to simulate a transmitted picture from the Lander. As we watched the first image appear, an undistinguished sandy surface was revealed. But then, in the midst of all this sand, a symmetrically jointed lobate object, perhaps 15 cm long, appeared (fig. 20). Alan Binder, standing next to me, exclaimed, "That's a trilobite!" (Trilobites are primitive arthropods that thrived in the early Paleozoic seas on Earth, hundreds of millions of years ago. Their external skeleton, with head, body, and tail, creates a distinctive fossil that is much prized by professional paleontologists and amateur rockhounds.)

With the test completed, we were allowed to see the scene that had been photographed. Our fears were unfounded. There, nestled among the sand ripples, was a magnificent replica of a Cambrian trilobite.

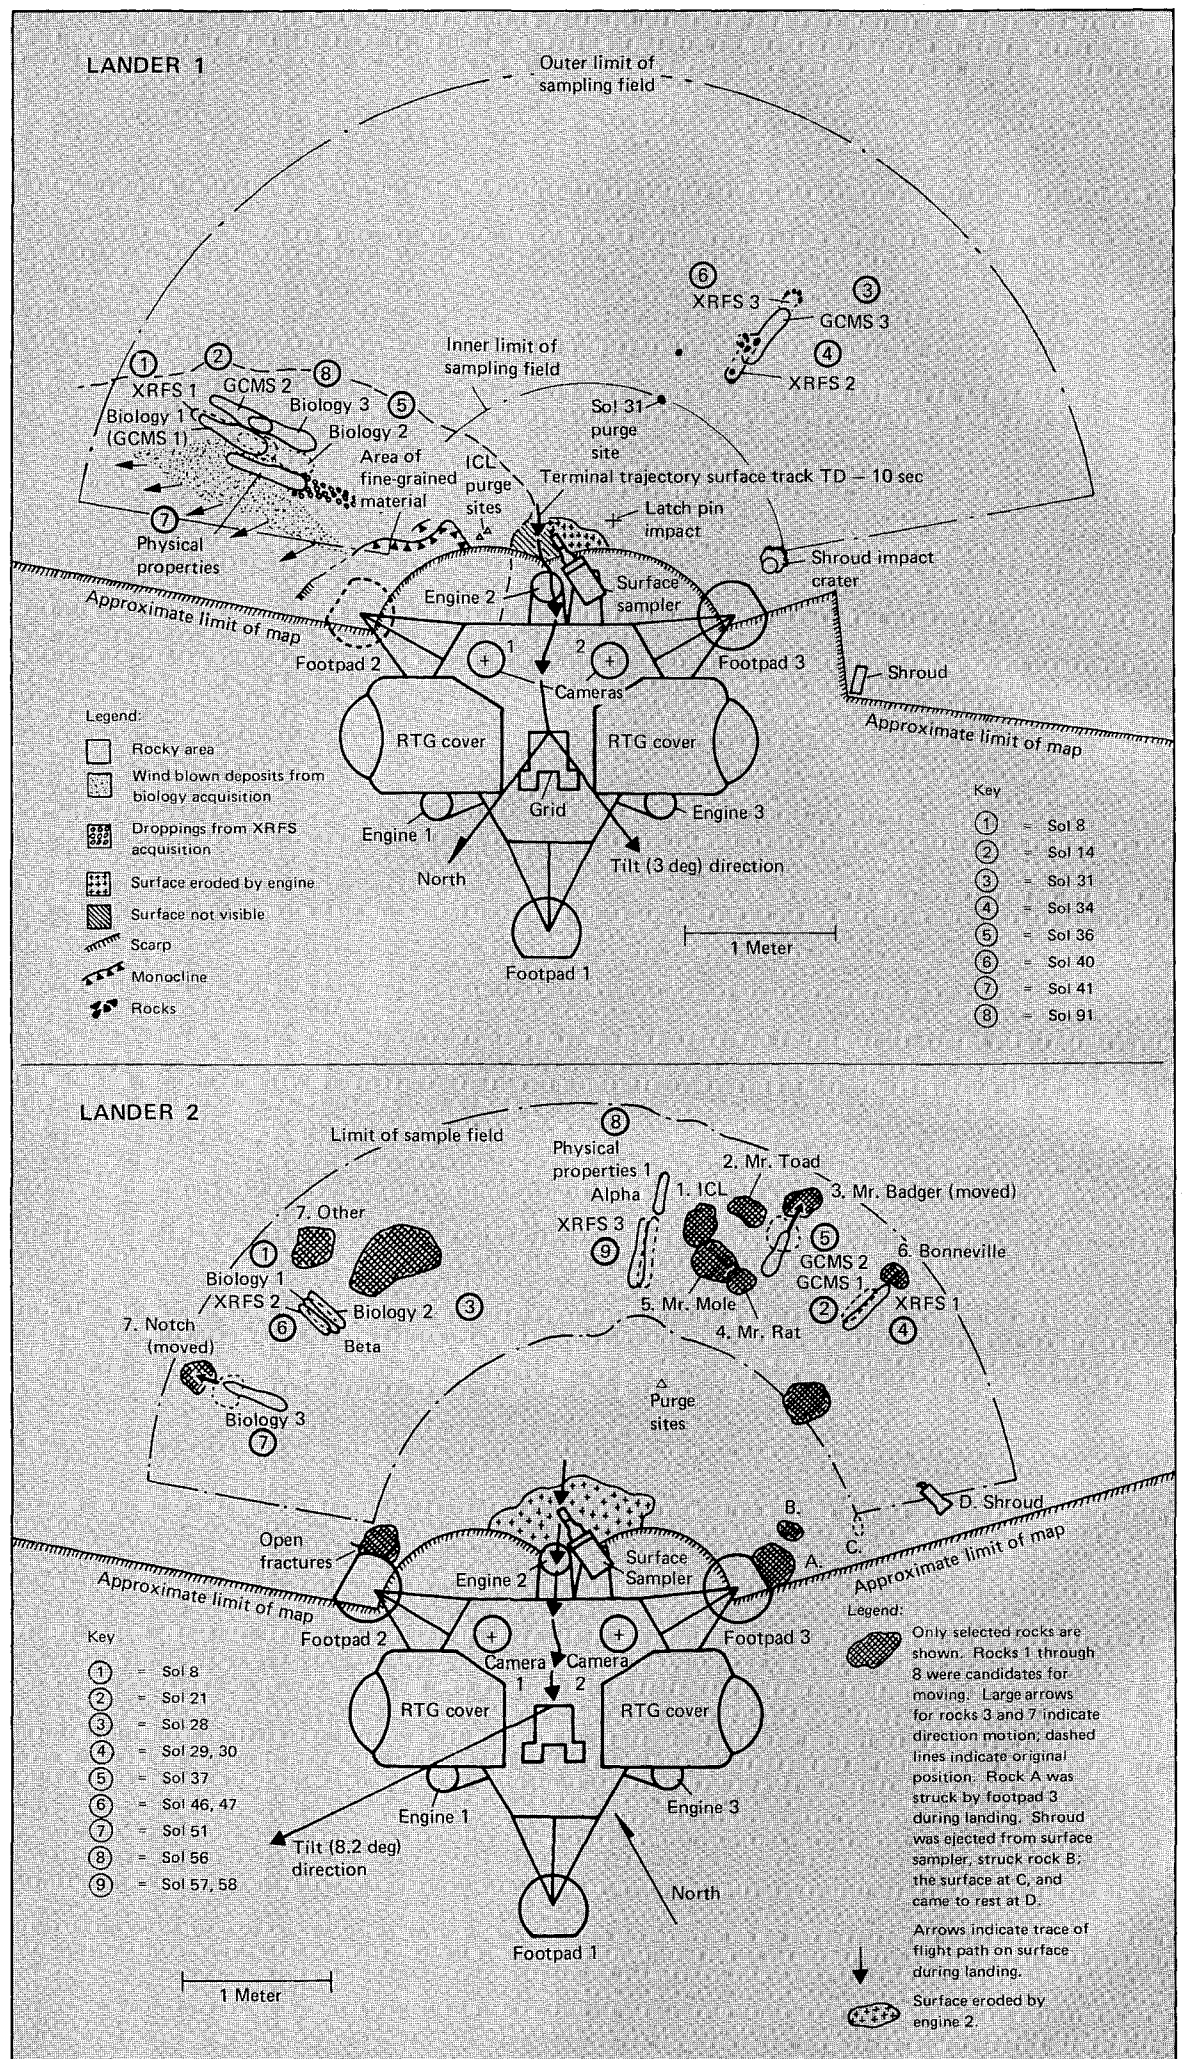
Figure 23. Schematic drawings of Lander 1 and Lander 2 sampling areas summarizing surface sampler activities during the primary mission. The numbered circles indicate, in sequence, the sample acquisitions. The key indicates the sol (martian day) on which each acquisition occurred.

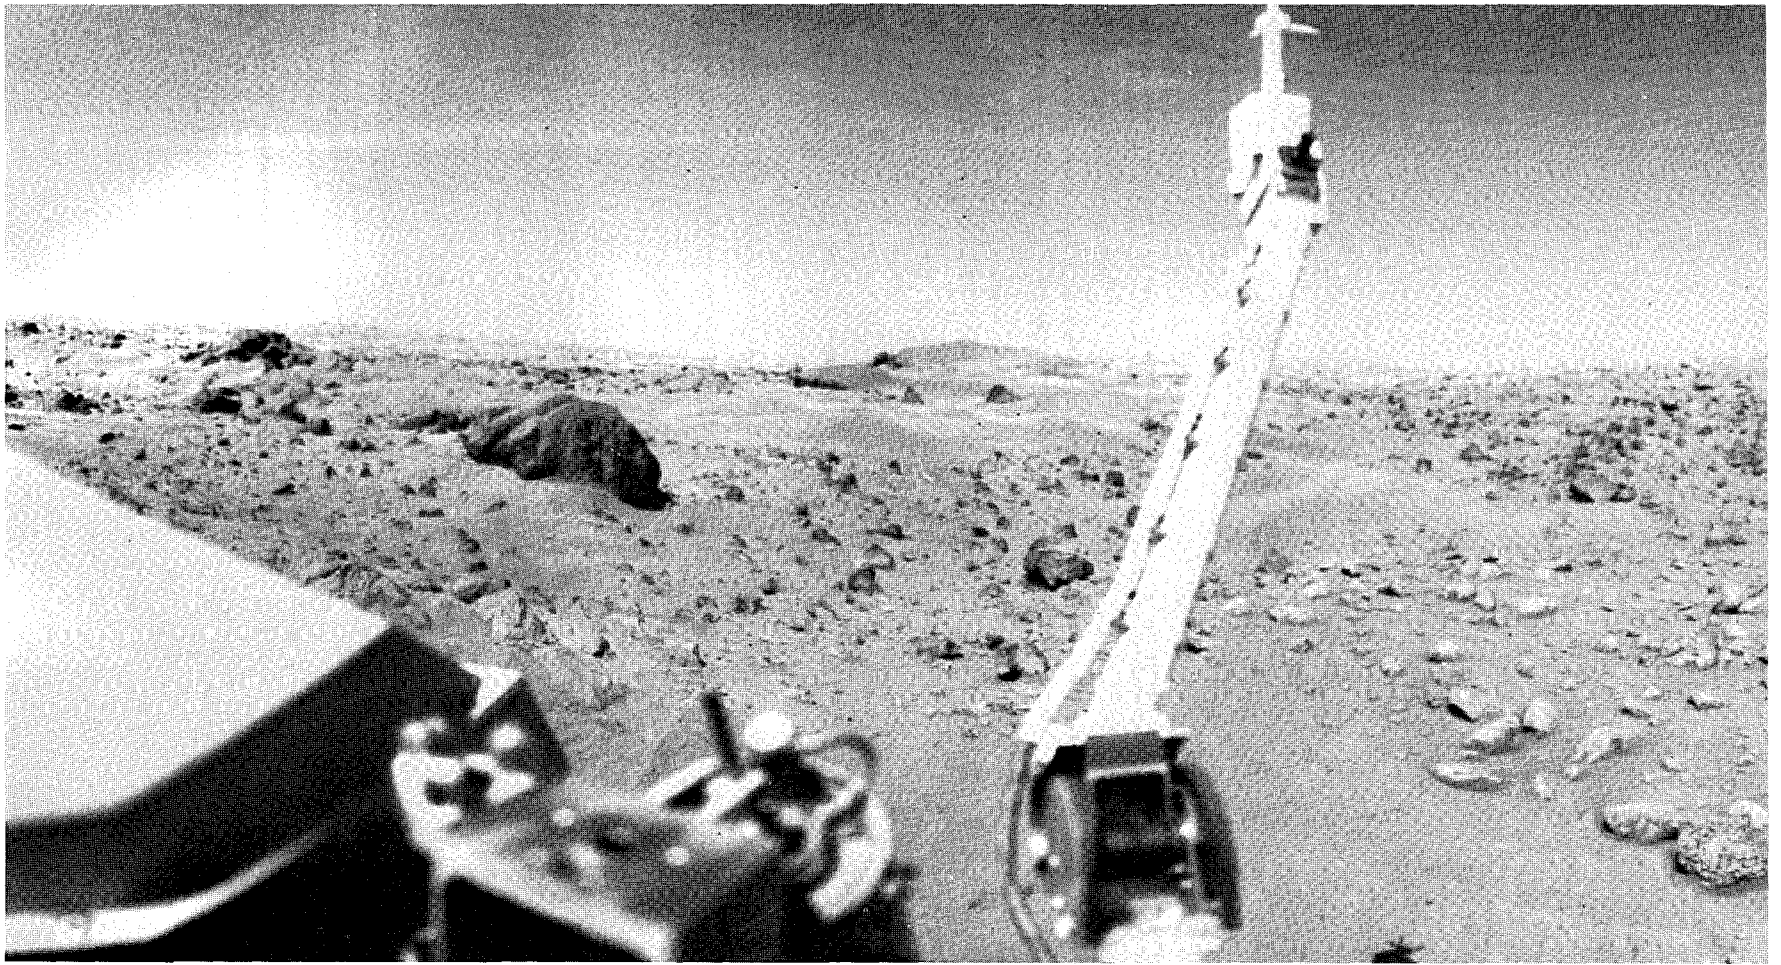
FIGURE 27

As remarkable as the first panorama was, the most dramatic part of the scene was contained in the 60° not covered. Only when we took an equivalent panorama with the other camera three days after touchdown (fig. 27), did we realize what we had missed on the first day—an impressive array of drifts and a large, distinctive boulder.

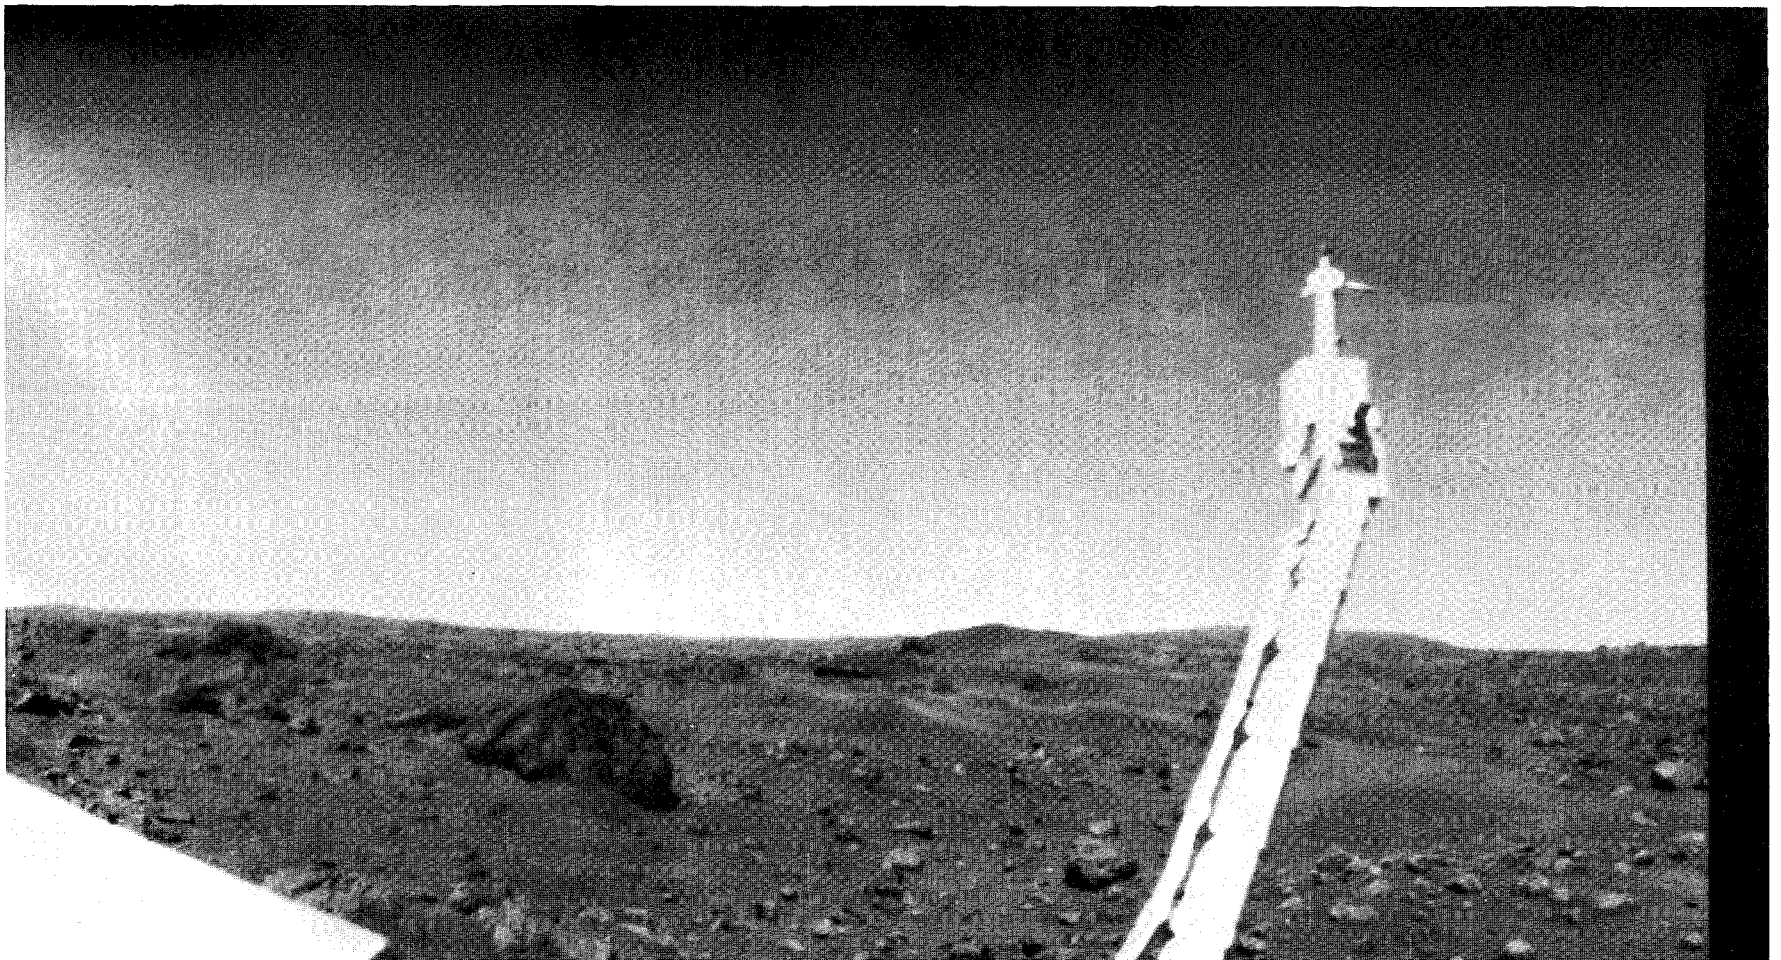
FIGURE 28

Figure 28 is a picture taken with the “blue” diode, recording brightness at the shorter wavelengths in the visible range. The meteorology boom appears in the foreground. The bright lower atmosphere is dramatically accentuated.

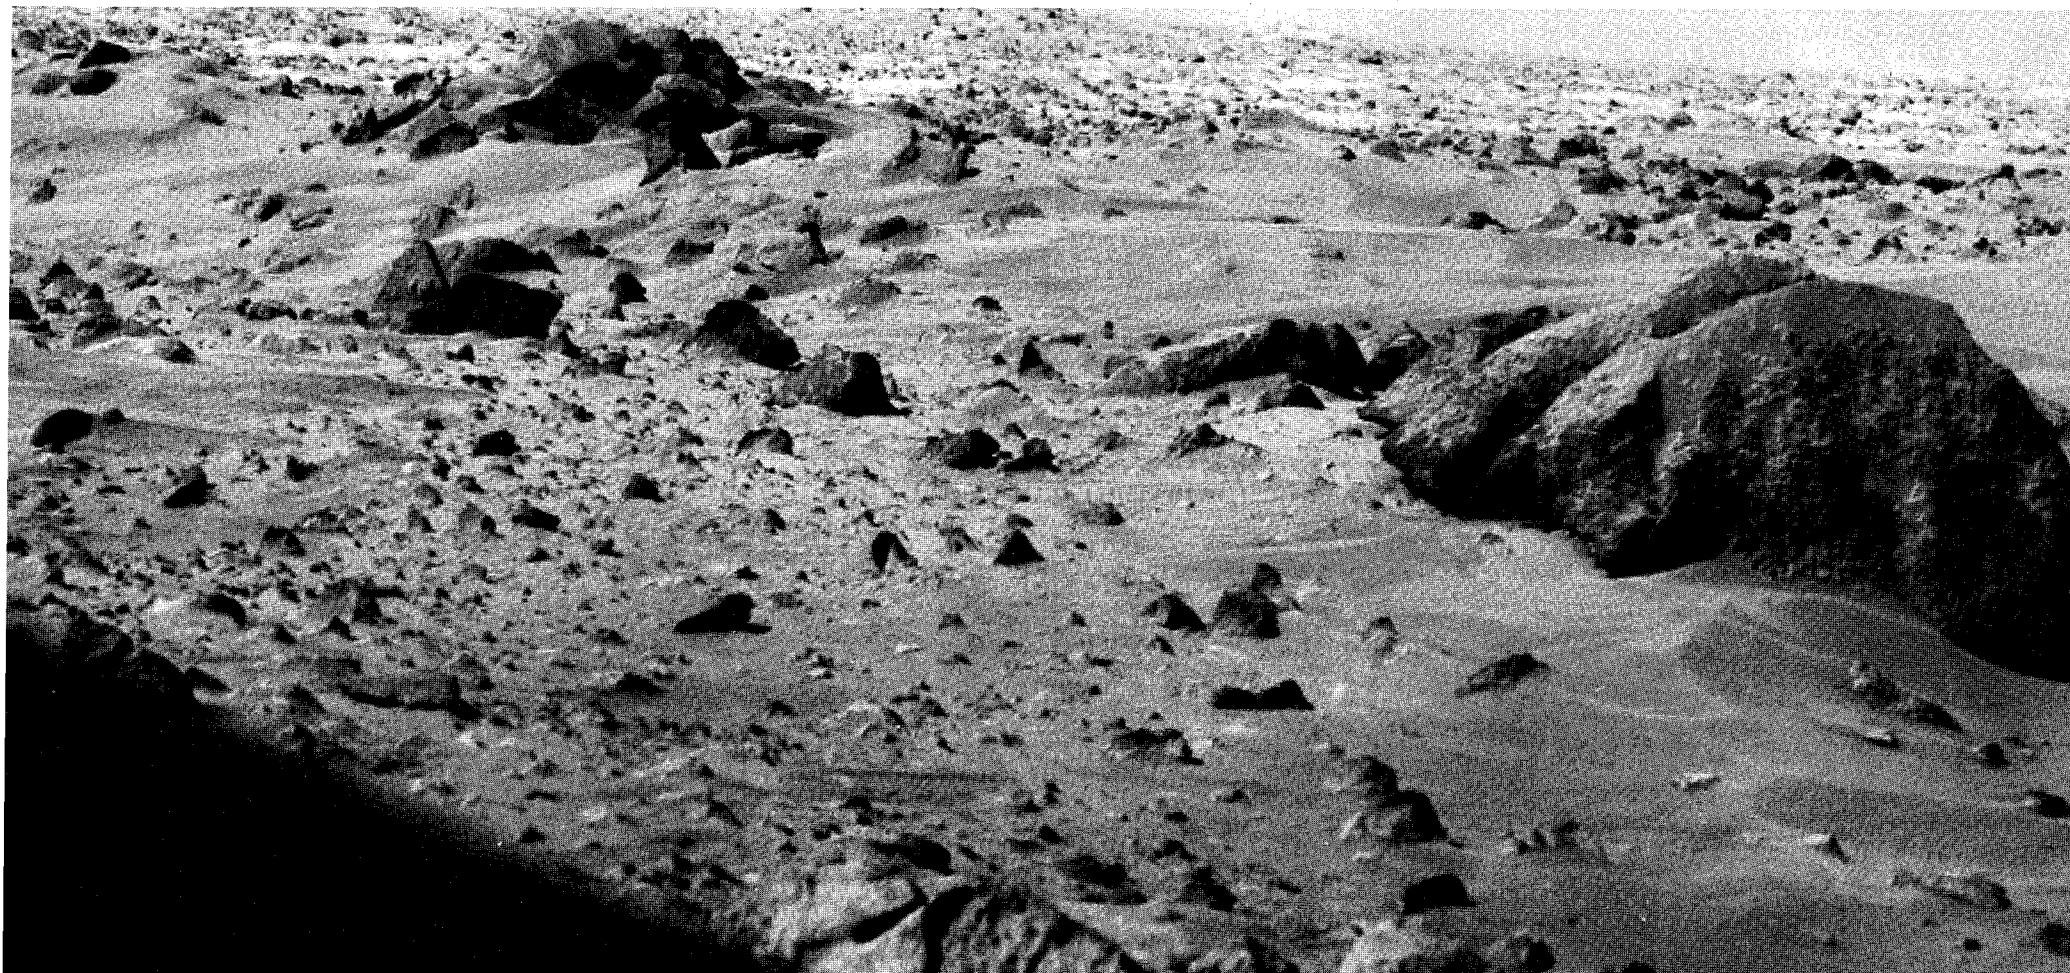
FIGURE 29

It is entertaining to compare these three views (figs. 29, 31, and 32) of the same region. The first was taken near noon, the second in early morning, and the third in late afternoon. Because of changes in lighting, each picture reveals different features within the scene.

Figure 30 should be compared with figure 29. The two were taken some nine months apart. The lighting is approximately similar. However, the details are *not* the same. Refer to the large boulder, nicknamed "Big Joe." Just below it, at the right, there is a small region of slumped soil visible in figure 30 but not in figure 29. For a geologist, trained to study the changing shape of planetary surfaces, this event is unusually exciting. It represents the first evidence of contemporary geomorphological change that we have witnessed on any planet other than

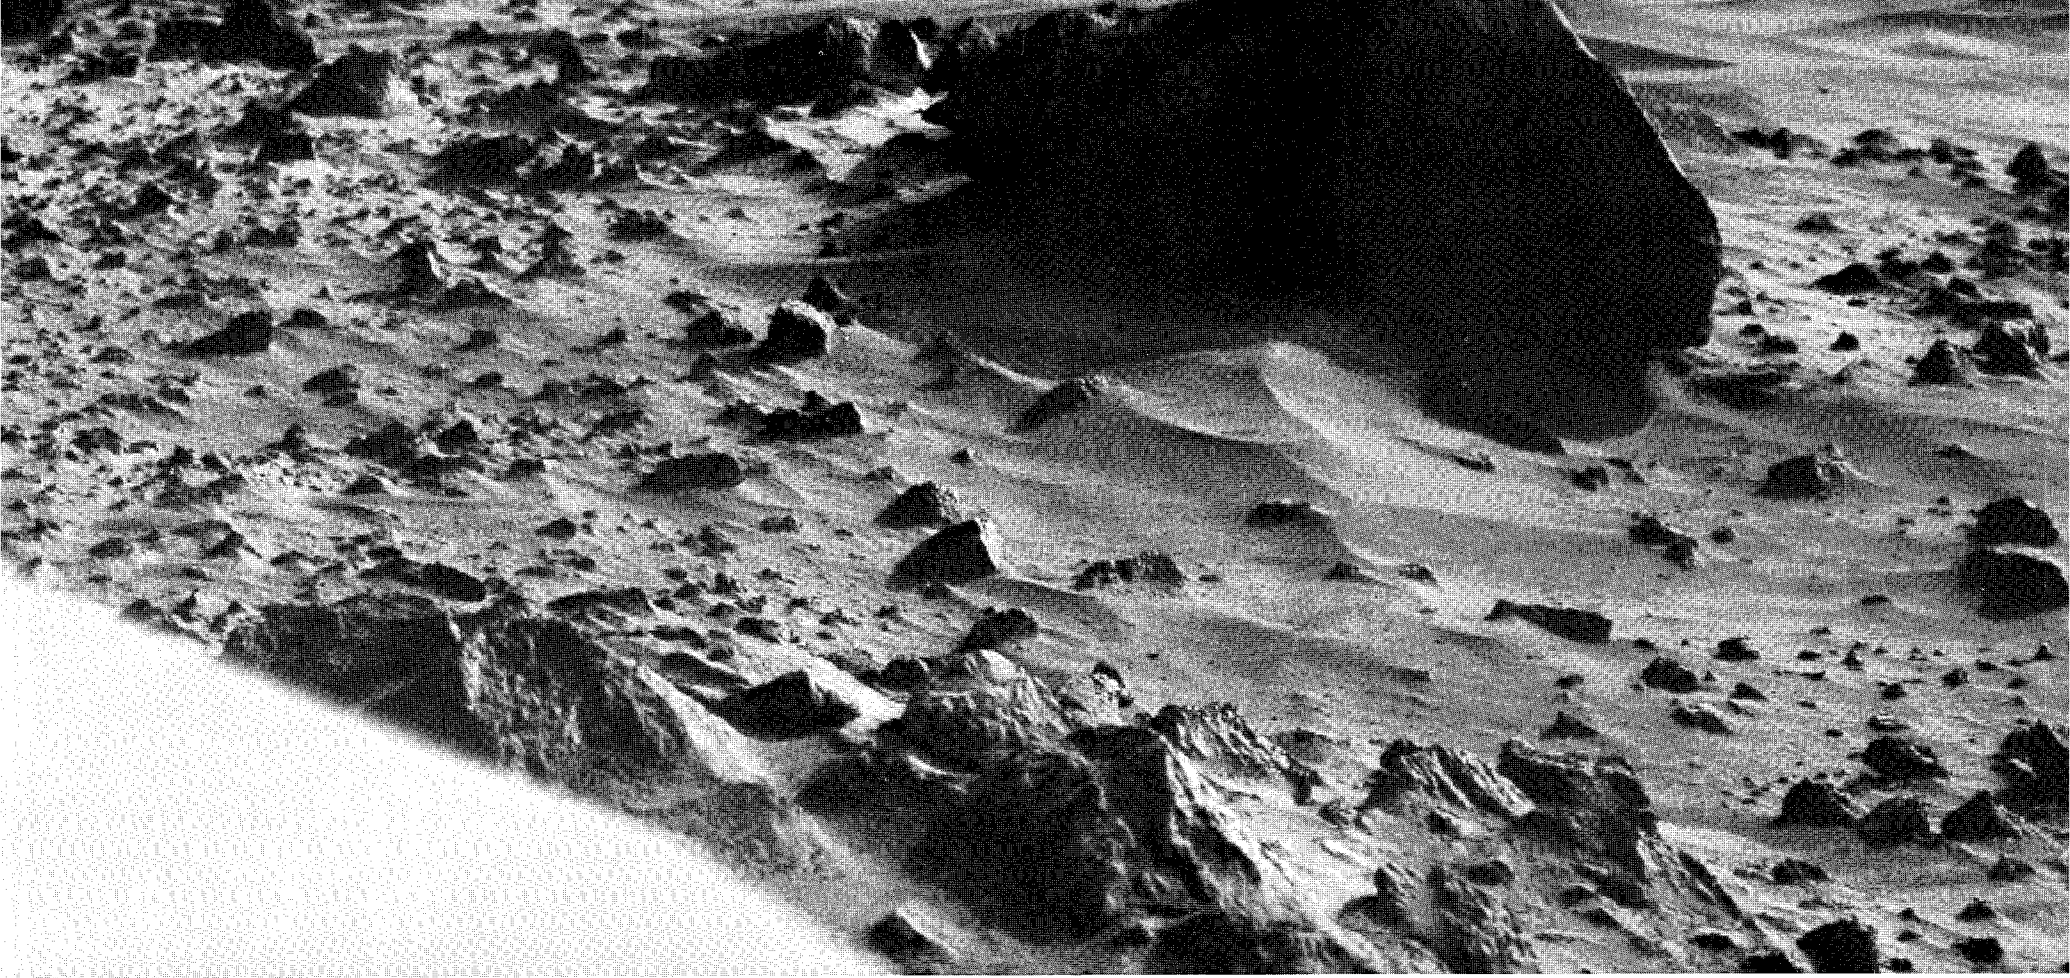
FIGURE 31

Figure 31 was the first of the three panoramas to be obtained. The rising Sun backlights the entire scene, sharply delineating drifts of sediment and shadowing a prominent boulder about 2 m across and 9 m from the spacecraft. This is probably the most publicized picture taken during the entire Viking mission. Within a day after it was released it appeared on the front page of virtually every major paper in the United States, and many other papers around the world. One editor, determined to reproduce the long panorama at optimum size, rotated the picture 90° and

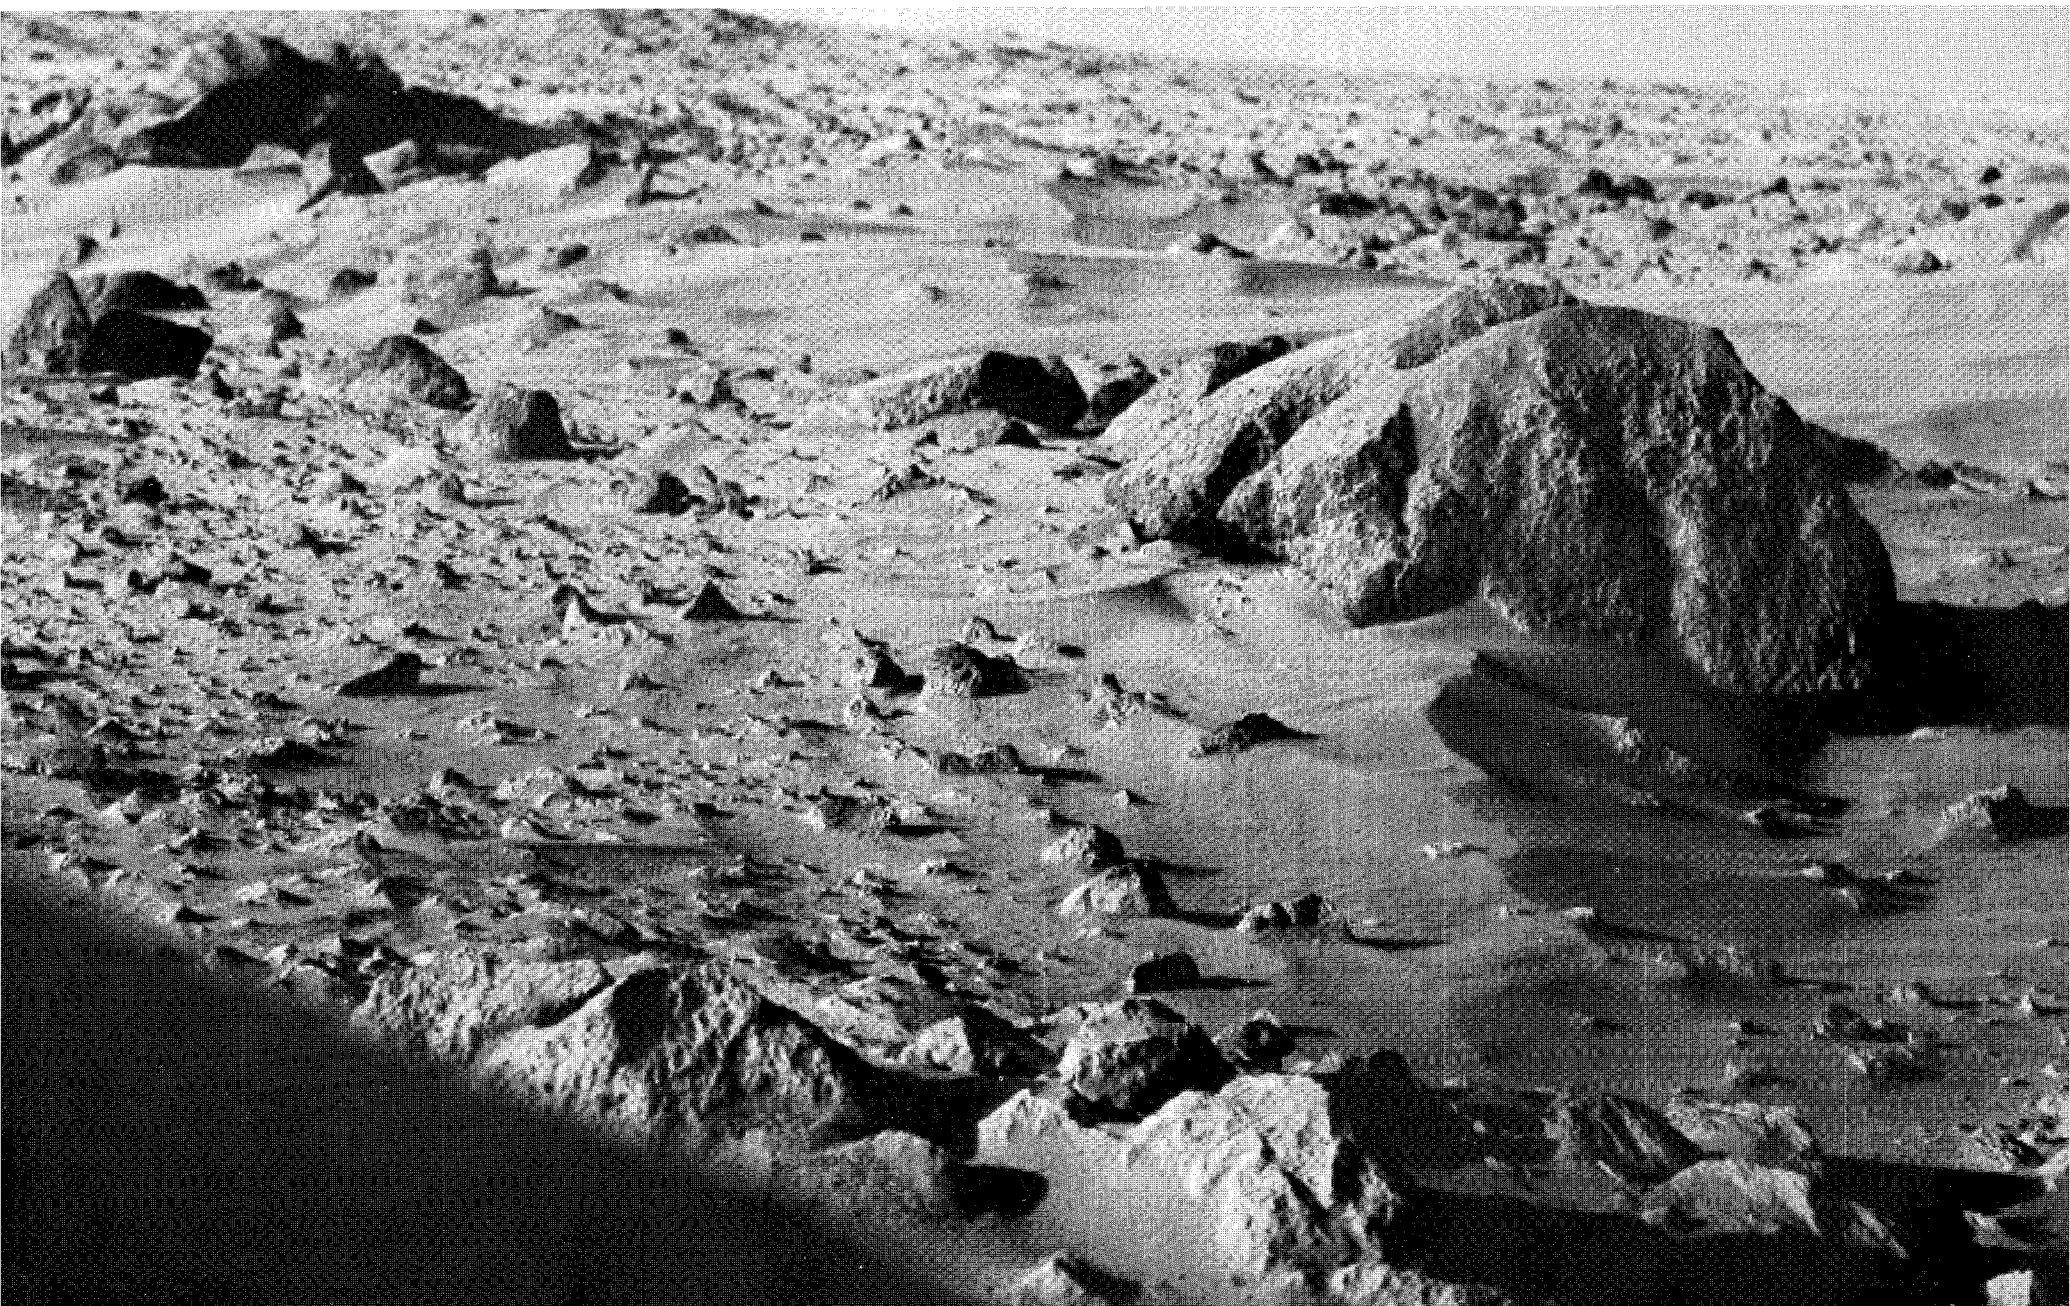
FIGURE 32

notch in the shadow (fig. 32). The two-boulder occurrence appears more consistent with splitting on impact than with erosion in place. Also, some analysts have remarked on the apparent ring-like arrangement of small blocks to the right of Big Joe. However, detailed mapping of the blocks fails to document any circular geometry.

Note that Big Joe is capped with fine-grained material. This may be a remnant of a much thicker cover of dust that formerly covered the entire region to a depth of several meters.

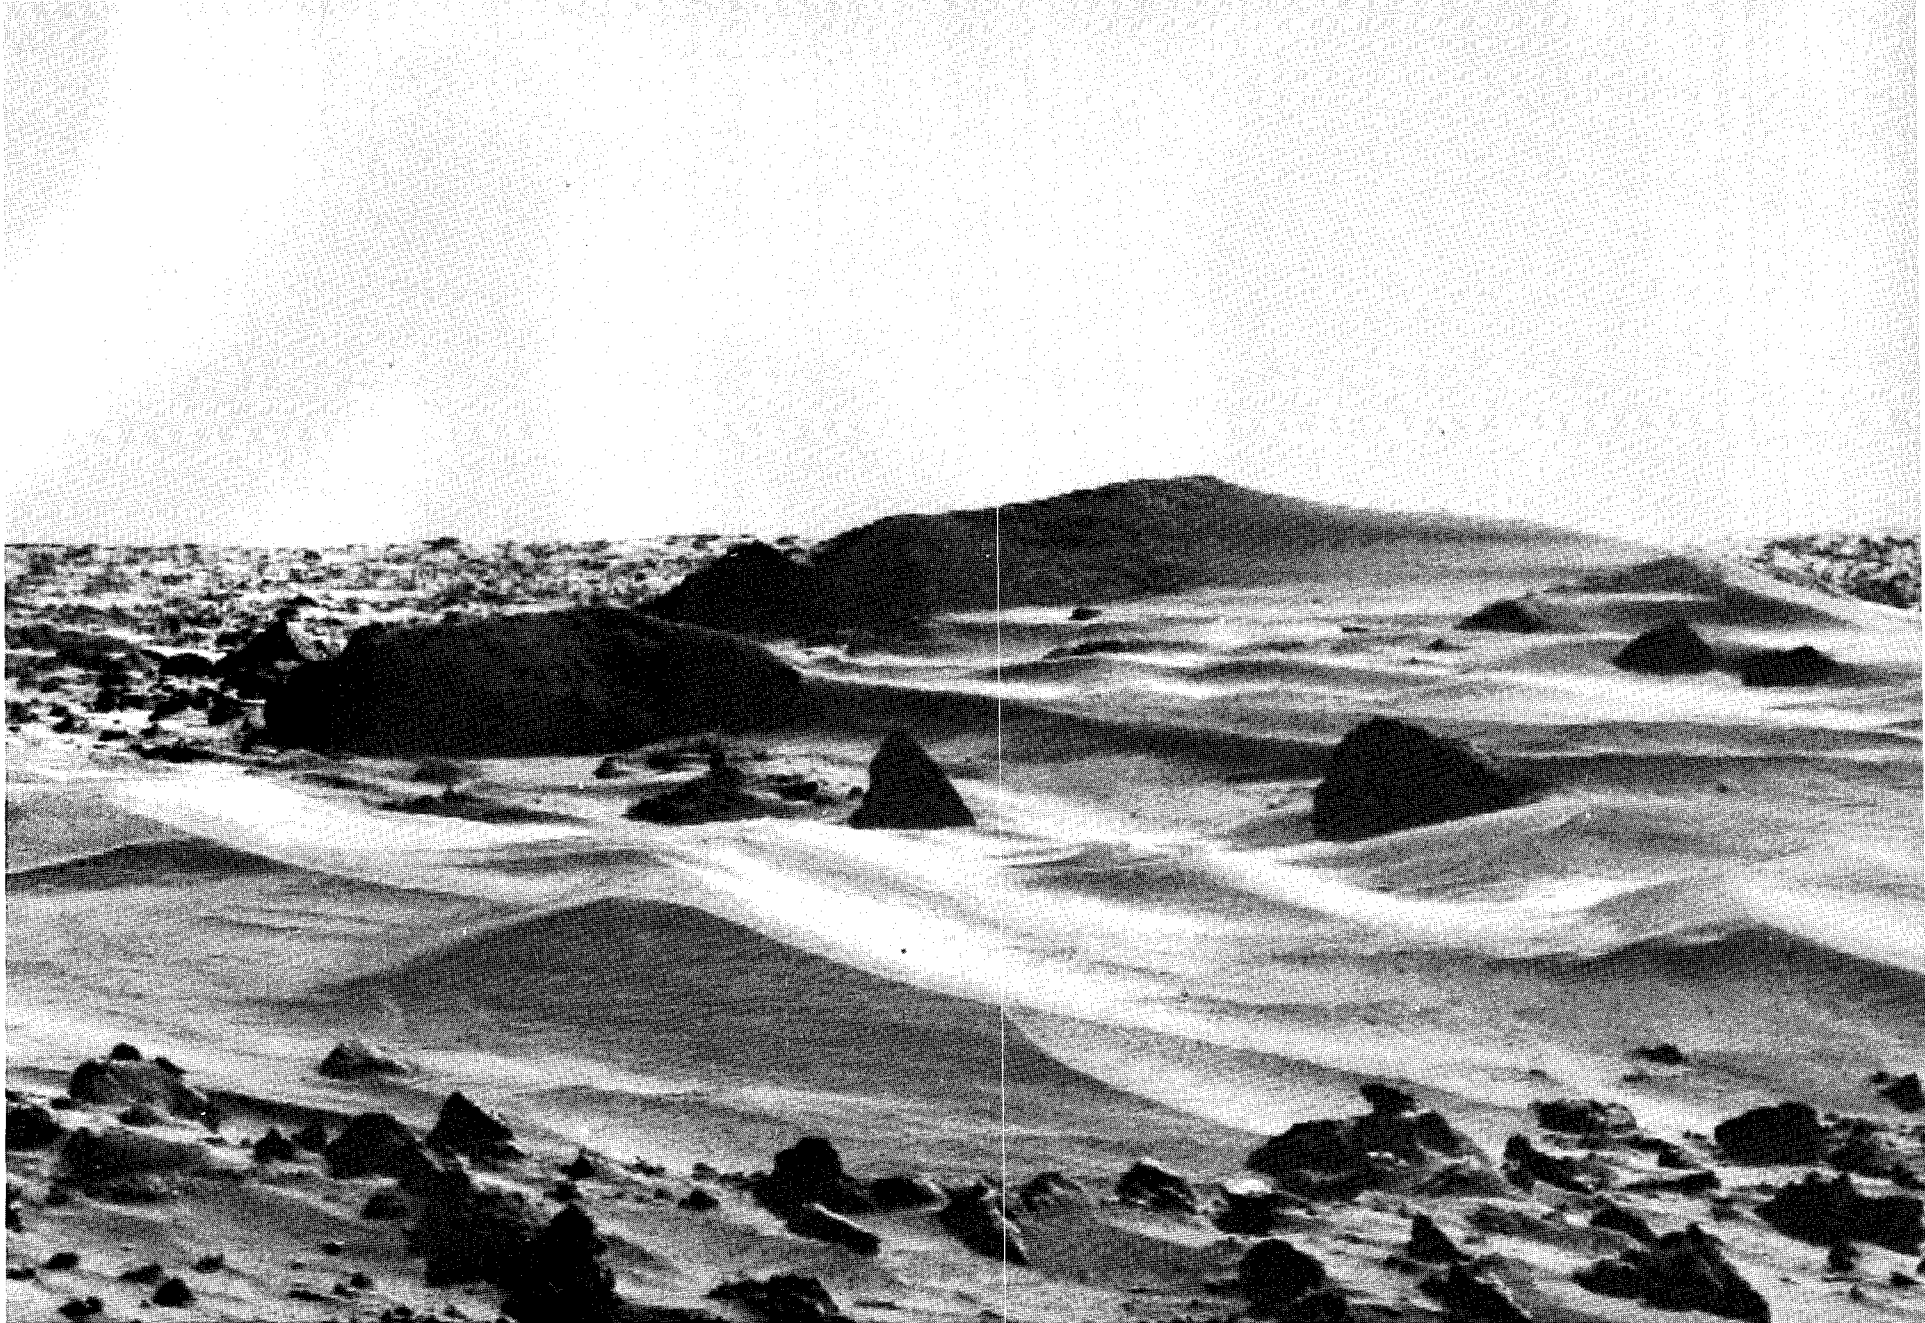
FIGURE 33

Figures 33 and 34 are two views of sediment drifts showing internal stratification. At first glance these appear to be sets of small-scale surface ripples. Closer examination reveals that the linear markings result from erosion of a sequence of sedimentary layers. The same sort of internal stratification can be seen on a seashore beach by trenching through the sand. On a much grander scale, internal stratification of desert dunes is revealed by erosion of Mesozoic rocks in the American Southwest, notably in Bryce and Zion National Parks. In figure 34 the drift at the right of the image displays several prominent ridges. Darker, more resistant layers are revealed on the eroded drift faces, covered by a thin layer of brighter material.

The presence of sedimentary layers within the martian drifts indicates a number of depositional events, each related to a change in the wind conditions. The exposure of the layers indicates that the most recent event is general erosion. If these were actively growing dunes the internal stratification would not be revealed.

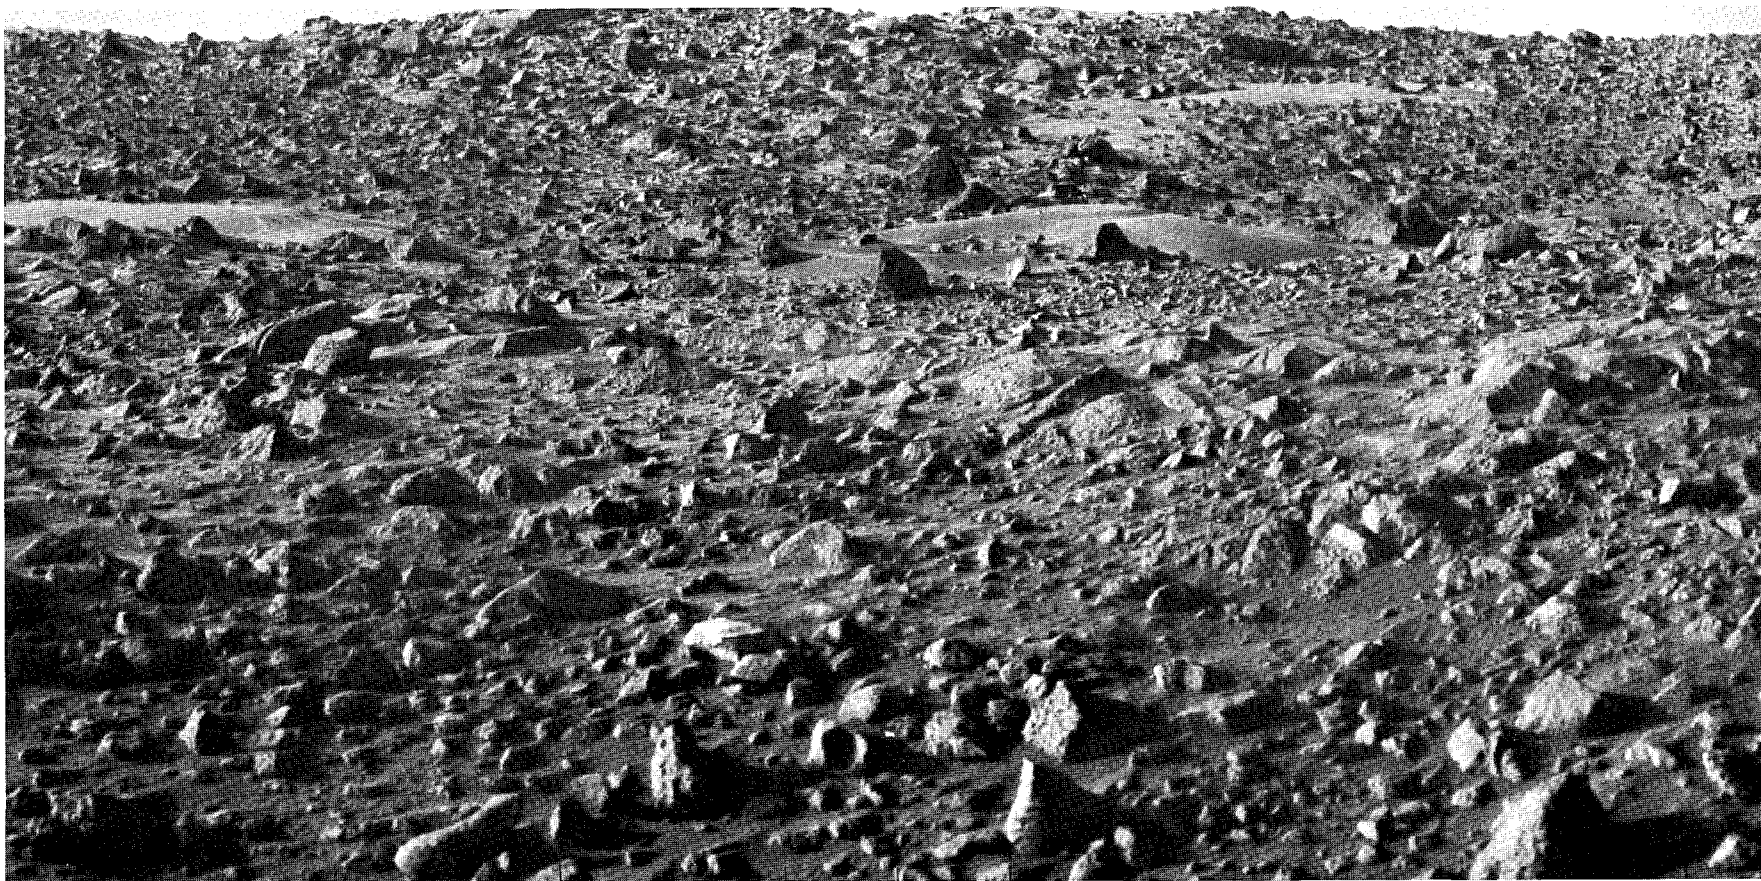
FIGURE 35

Figure 36 was taken with diode BB-3 (high resolution, focused at 4.5 m). Better definition of distant objects is rendered in figures 35, 37, and 38, taken with BB-4 (high resolution, focused at 13.3 m). Figures 35 and 37 were taken at approximately the same early-morning hour. Figures 36 and 38 were taken near local noon; Sun elevation is about 50°.

The same dark drift that appears in the upper right of figures 35 and 36 is situated in the middle of figures 37 and 38. A much brighter drift is observable in the upper left of figures 35 and 36. The difference in brightness (albedo) suggests a compositional difference. This is substantiated by spectral curves generated from data in the three visible color and three infrared channels. The shape of the spectral reflection curves indicates that the dark dune is enriched in ferrous materials, perhaps the mineral magne-

Near the bottom center in figure 36 there is a cylinder-shaped rock. In early news briefings this was nicknamed the "Midas Muffler" rock. However, the same rock as viewed in figure 35 is not so striking—less of a muffler, more of a garden variety boulder.

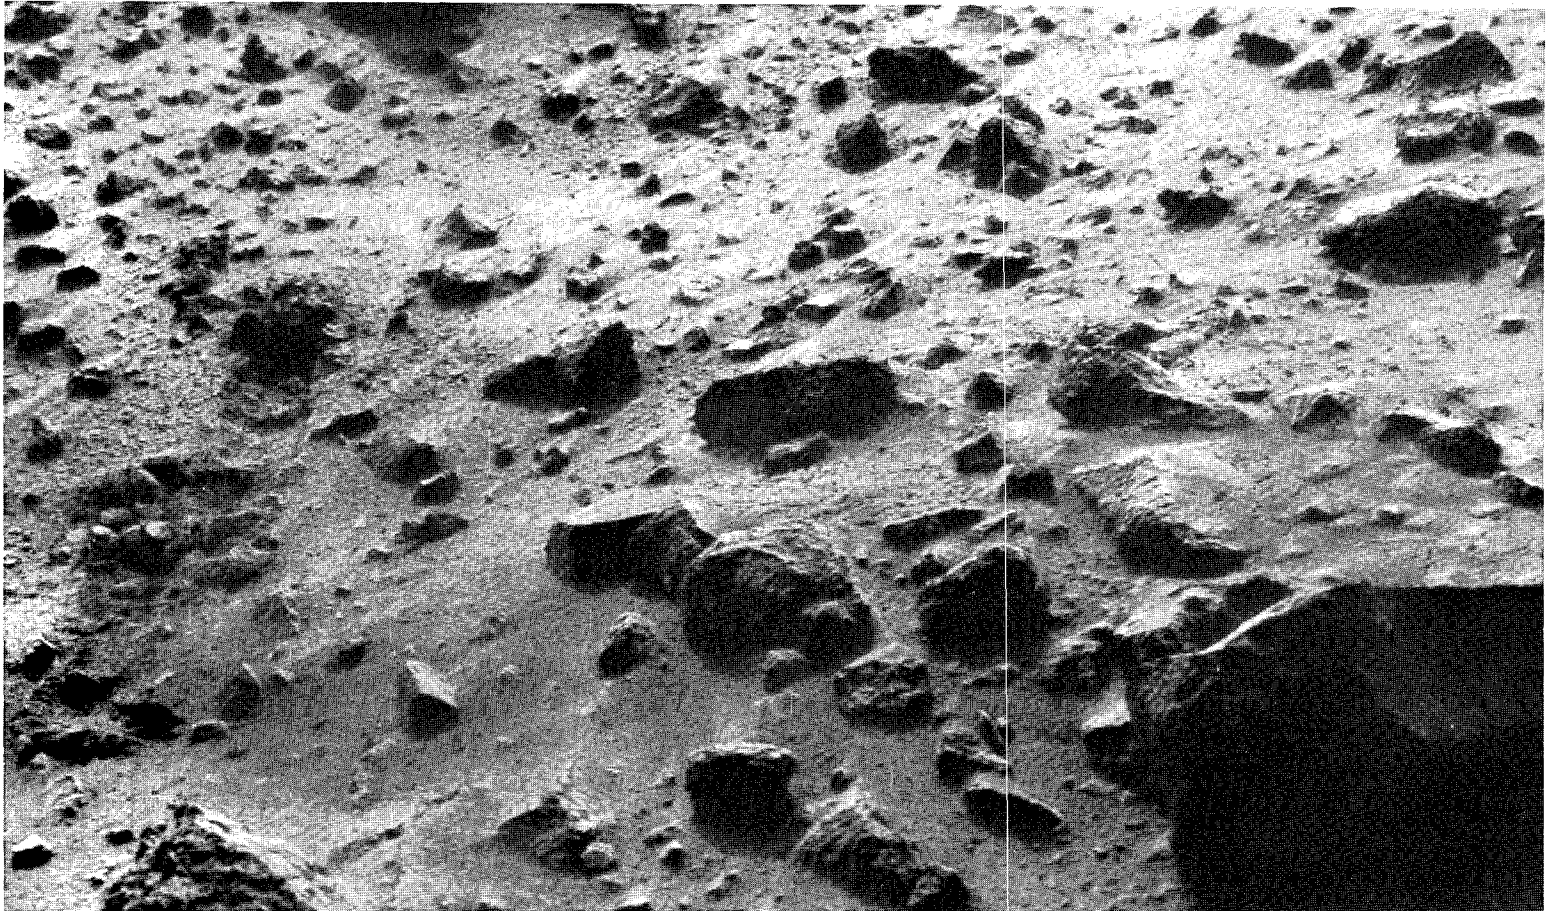
FIGURE 41

Whatever their origin, the blocks make fascinating pictorial designs, especially when deeply shadowed by an early morning or late afternoon Sun. Figure 41, taken during the extended mission when a global dust storm darkened the atmosphere, gives quite a different impression than that given by figures 39 and 40.
